RESTRUCTURING AND RENOVATING BUILDINGS:
FROM PROBLEM TO SOLUTION

Restructuring

A single partner to solve all problems related to the restructuring of buildings

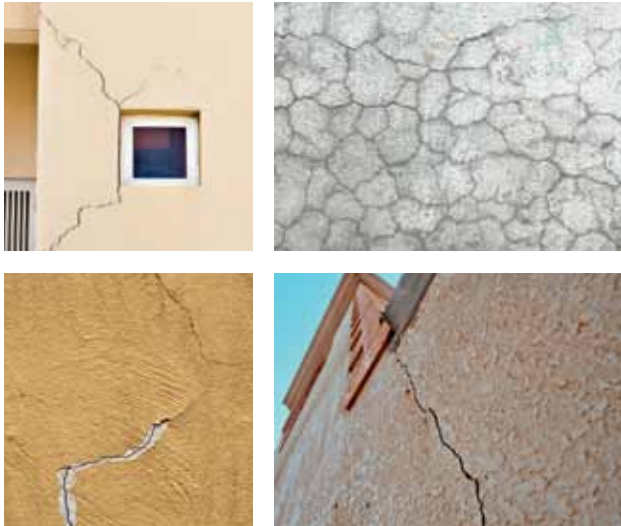
Visible cracks, such as crazing and fissures, are not merely an aesthetic problem but a threat to the structural integrity of a building.

Colorificio San Marco has developed ELASTOMARC, a specific system fine-tuned to repair façades affected by crazing and cracks.

The system is suitable for treating micro-shrinkages and cracks caused by vibration, or by expansion induced by differences in the thermal coefficient of the building's materials.

It can also be used to bridge wide cracks with a maximum breadth of 2000 μm , including those affecting wall structures.

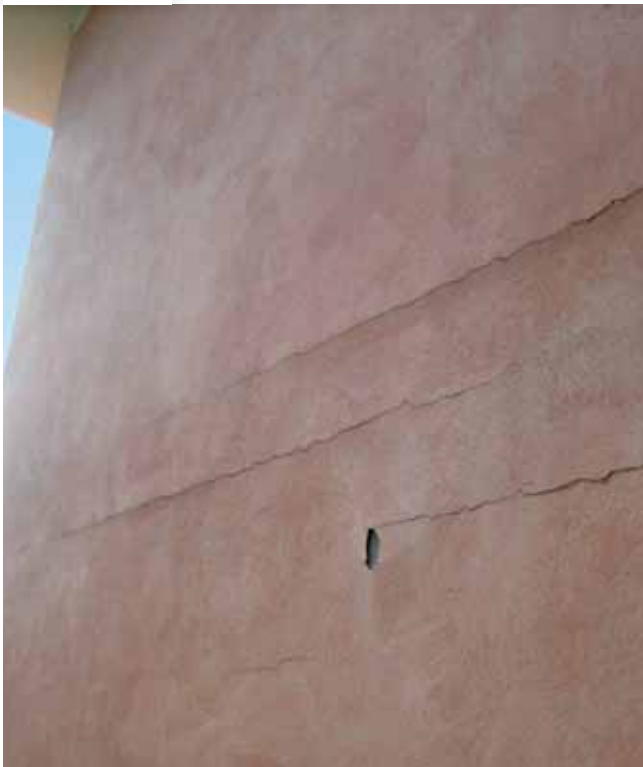
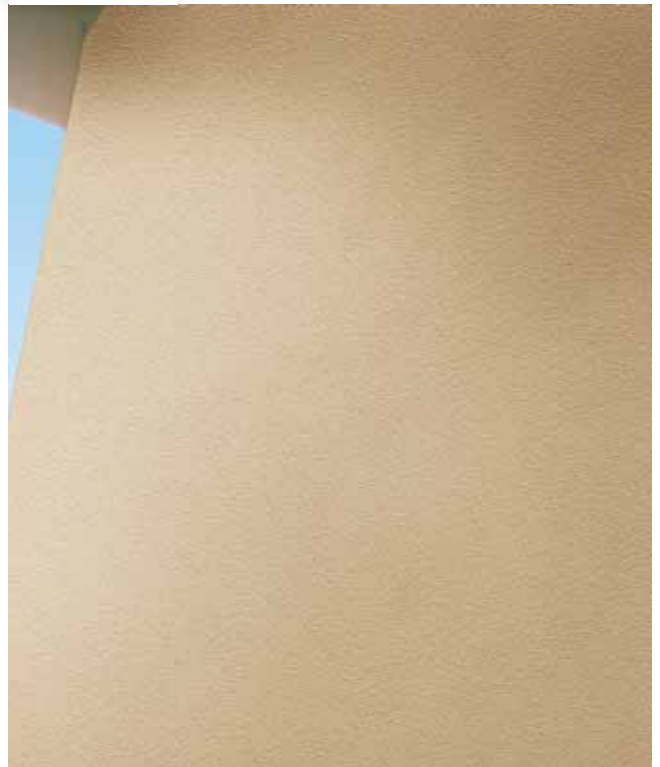
BEFORE

AFTER

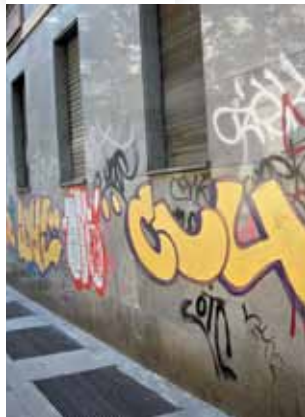
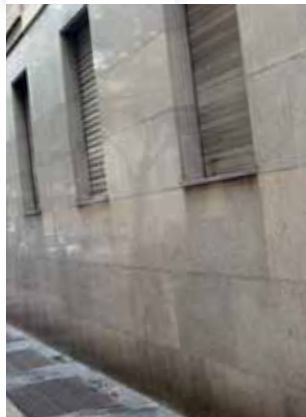
BEFORE

AFTER

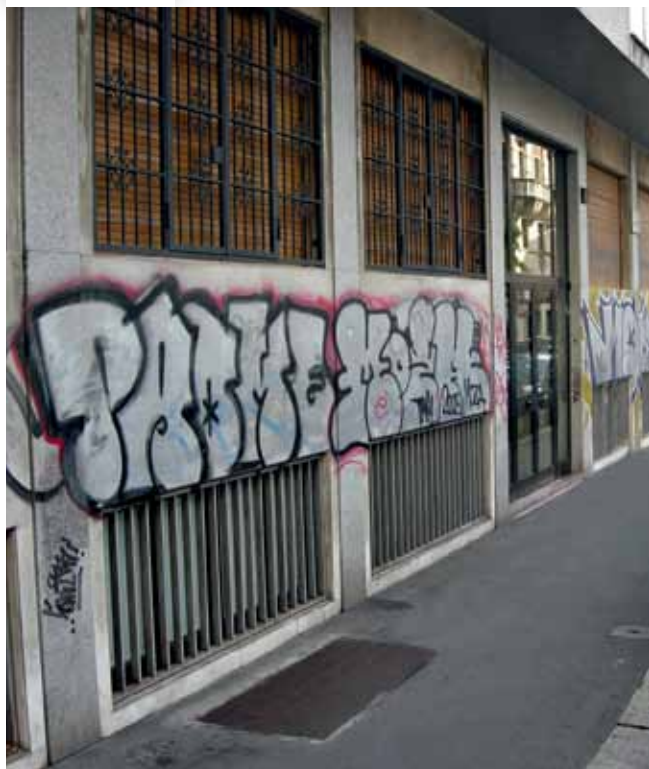
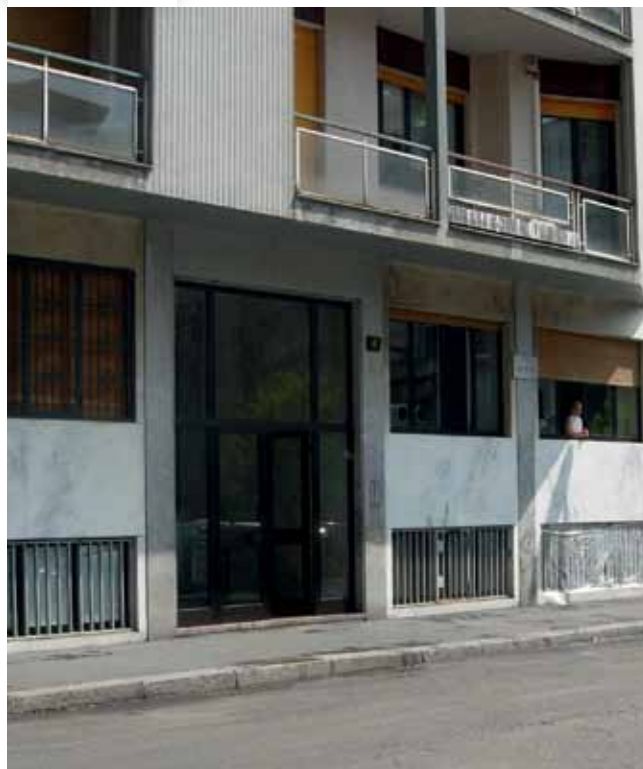
BEFORE

AFTER

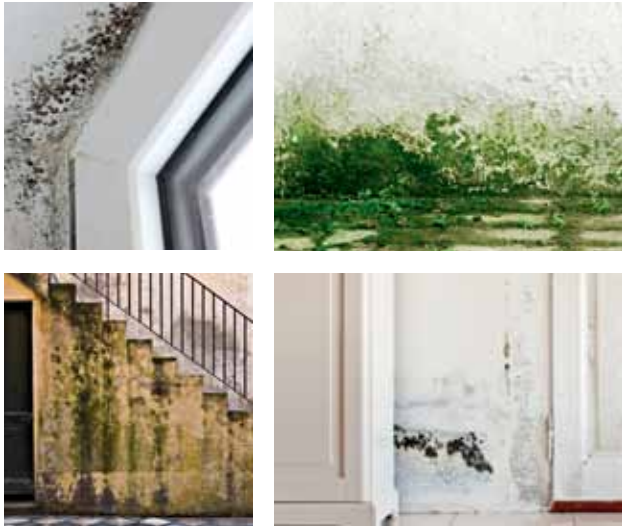
Biological degradation agents can compromise the looks and integrity of internal and external wall surfaces representing a threat not only to ageing or decaying edifices, but also to new ones that show no sign of deterioration.

Biological degradation results from the proliferation of various kinds of organisms (mould, algae, mildew and lichen) on walls and in the surrounding ambient air, which represent their ideal habitats.

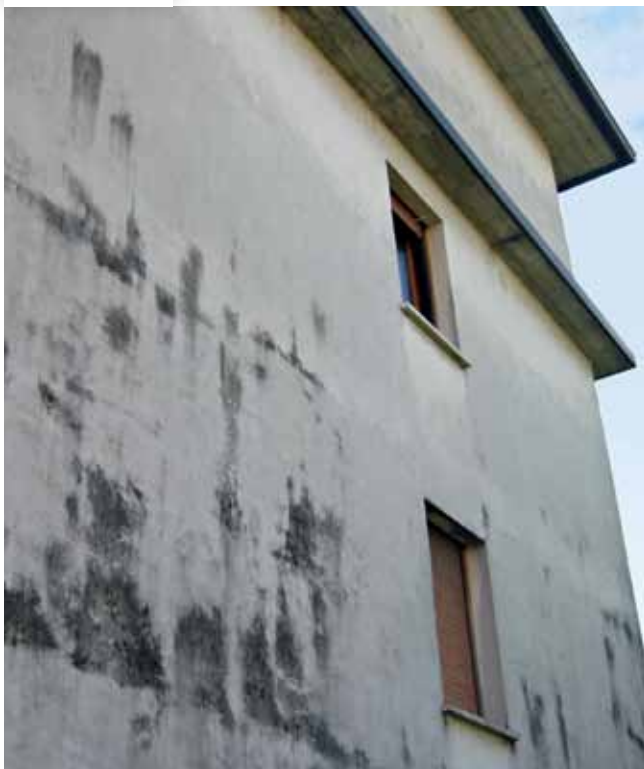
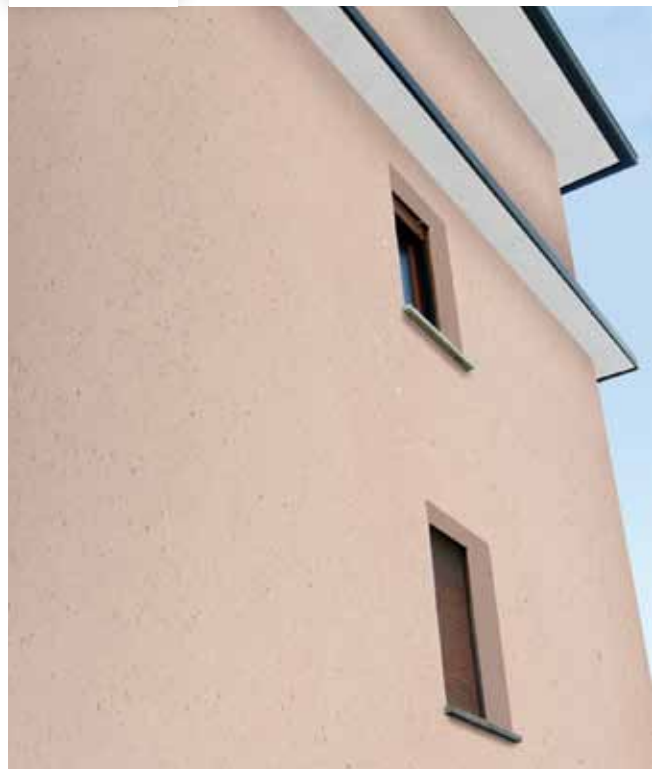
BEFORE

AFTER

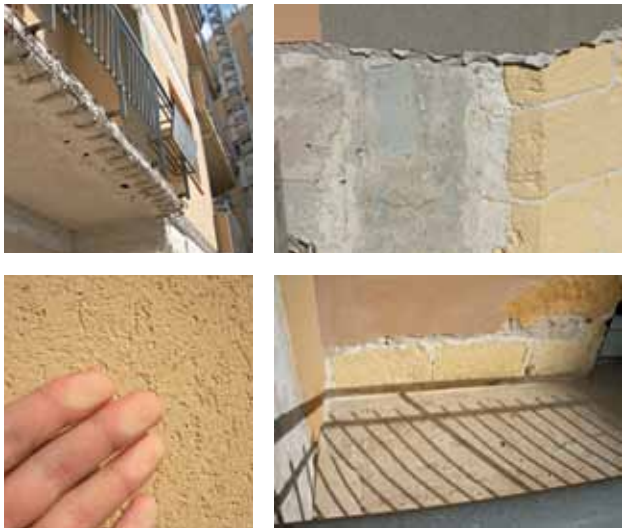
Exposure to adverse weather conditions and to aggressive pollutants accelerates the degradation of plaster, causing crumbling and flaking of varying degrees, and even severe damage.

Restoring extremely degraded façades involves the application of a remediation cycle of specific materials to consolidate the plaster and to repair any missing parts.

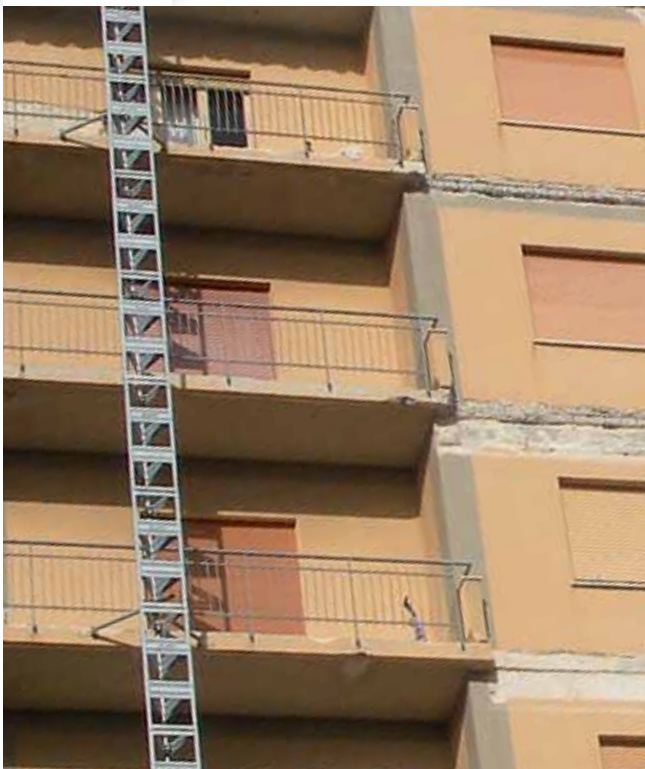
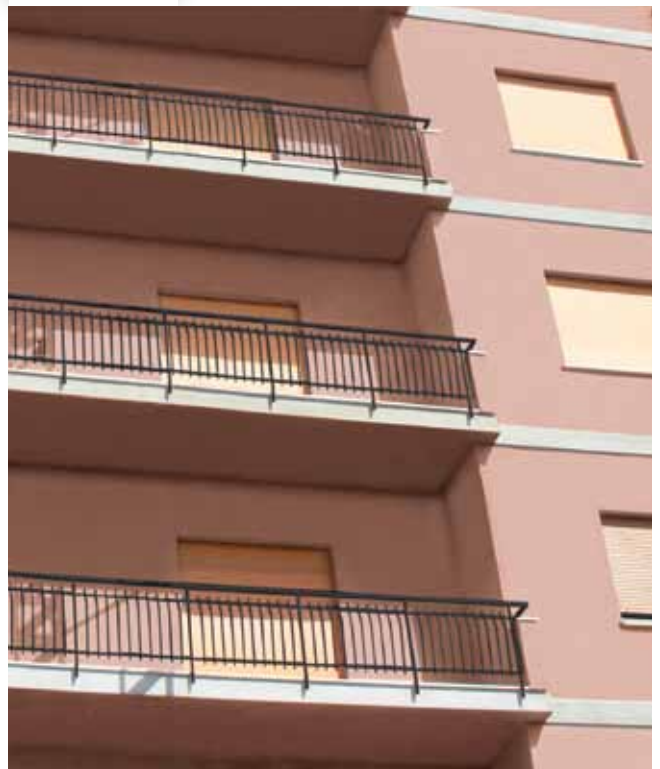
BEFORE

AFTER

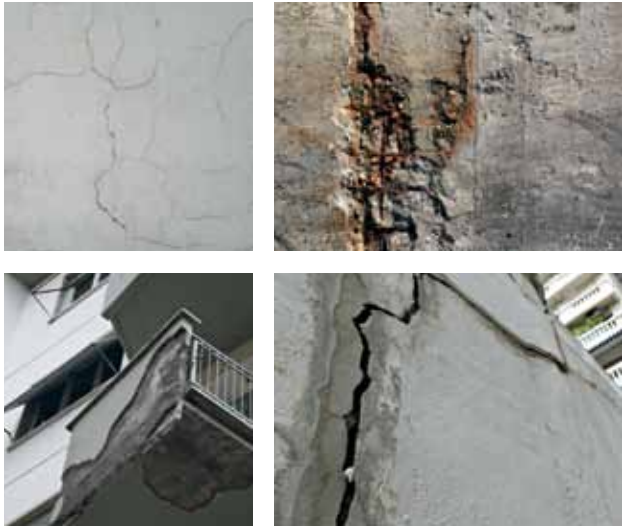
Concrete is one of the most widely-used and versatile materials in the modern construction industry. Despite its innumerable advantages, however, concrete is subject to natural deterioration. Colorificio San Marco has developed a system formulated for the preventive protection and restoration of both new and deteriorated concrete structures.

- High porosity of concrete
- Exposure to aggressive ambient conditions
- Repeated freeze-thaw cycles
- Faults in the design, or exceptional events (foundation movements) which can cause cracking
- Carbonation

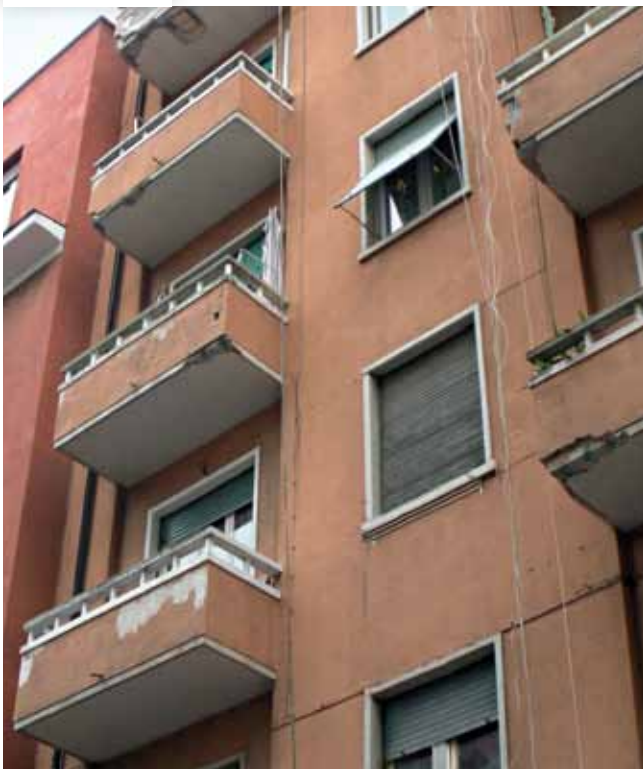
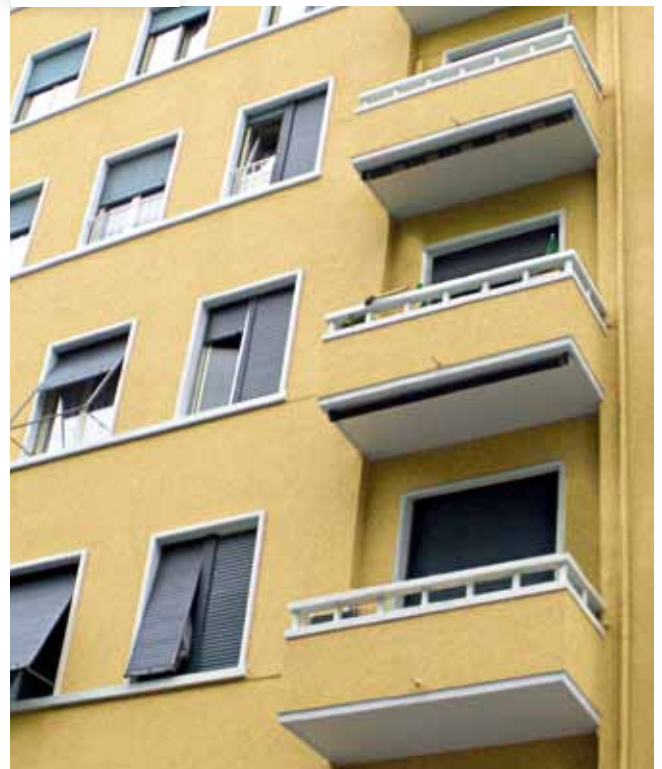
BEFORE

AFTER

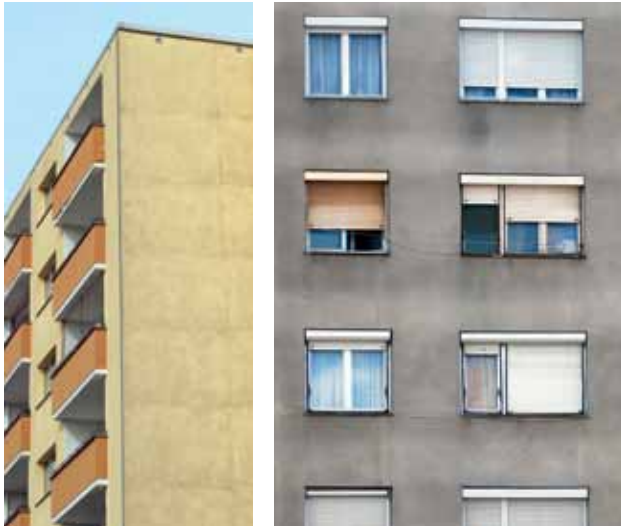
Thermal bridging occurs when certain building components - whose thermal conductivity is relatively high compared to the rest of the structure - create pathways for heat loss.

In these points, the difference between the various construction materials (such as brick walls and reinforced concrete structures), causes a thermal "short circuit" which results in localized cold spots that form condensation. In these situations a reduction in the walls' overall insulating capacity is registered, entailing negative repercussions on living comfort, and the risk of fungal/mould proliferation.

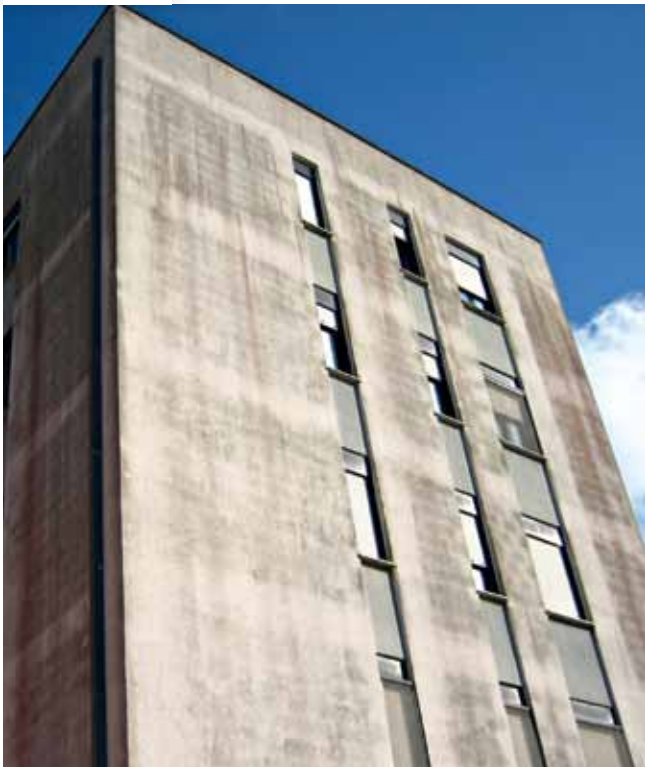
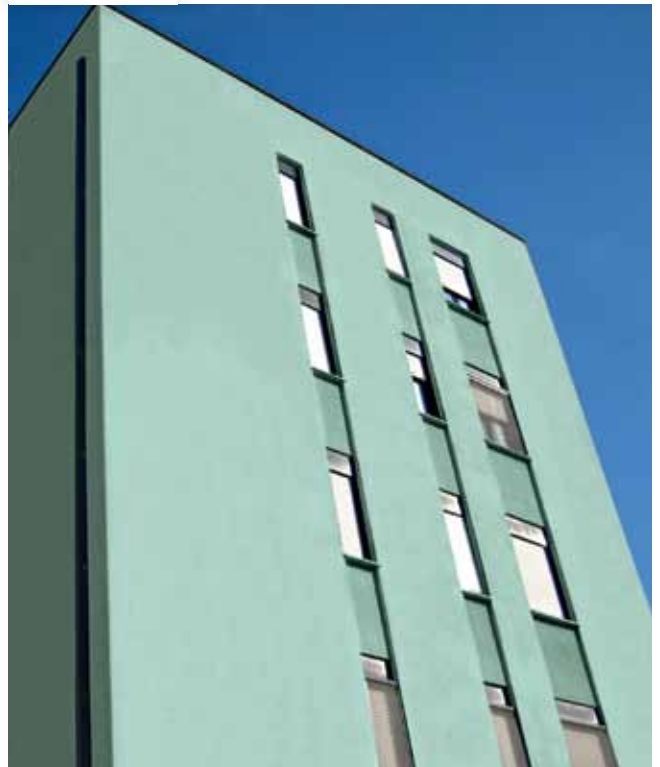
BEFORE

AFTER

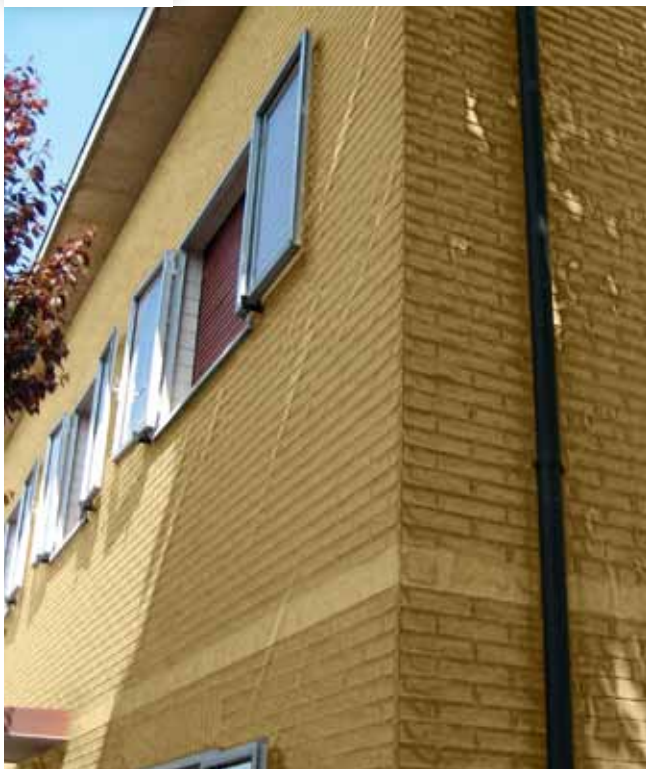
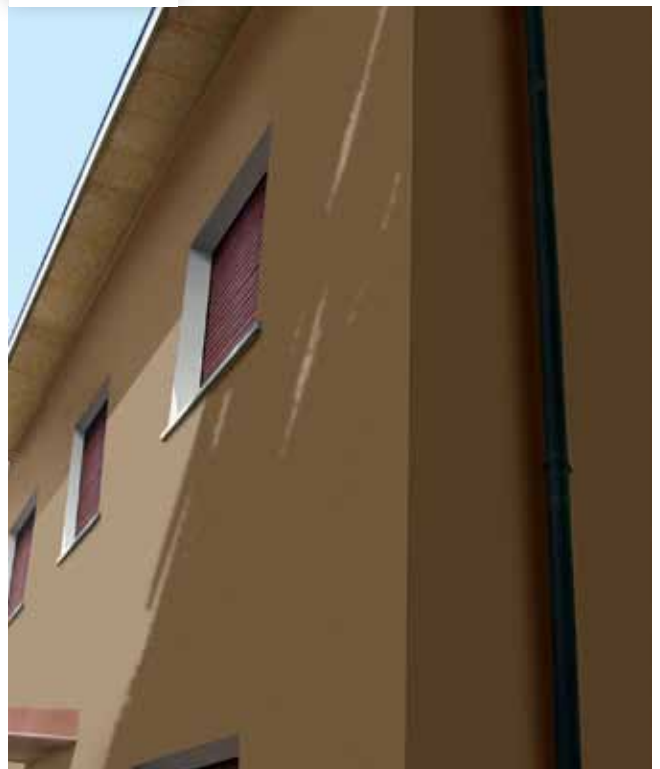
The renovation of ceramic-covered facades, in constant demand, often involves extremely long, laborious works, and the high cost of removing and disposing of the debris.

BEFORE

AFTER

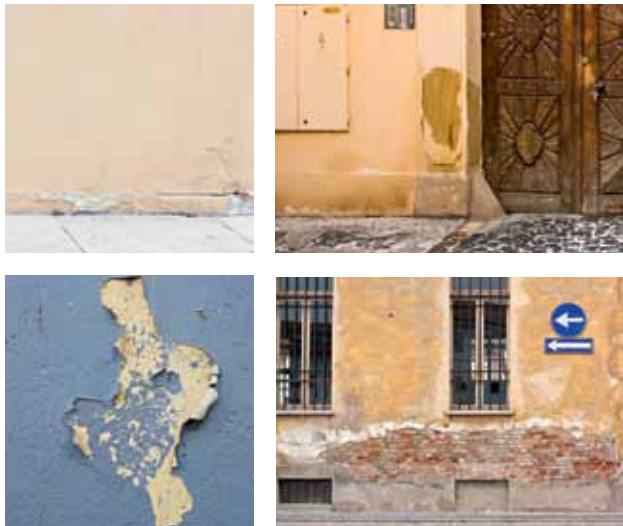
Dampness is a common problem in old buildings, and even in recent edifices which have not been protected through adequate waterproofing. This condition, which adversely affects living comfort, reveals itself through tell-tale signs on the walls, such as chalking, surfacing salts, mould and algae, flaking paint, degraded and crumbling plaster.

The problem of rising damp can be addressed and solved effectively by using a dehumidifying system capable of releasing the moisture absorbed from the ground through the micro-porous texture of the plaster itself. For this purpose, Colorificio San Marco has developed the NEPTUNUS system: these products combine to keep the level of humidity under control, releasing excessive moisture from the wall in the form of aqueous vapour.

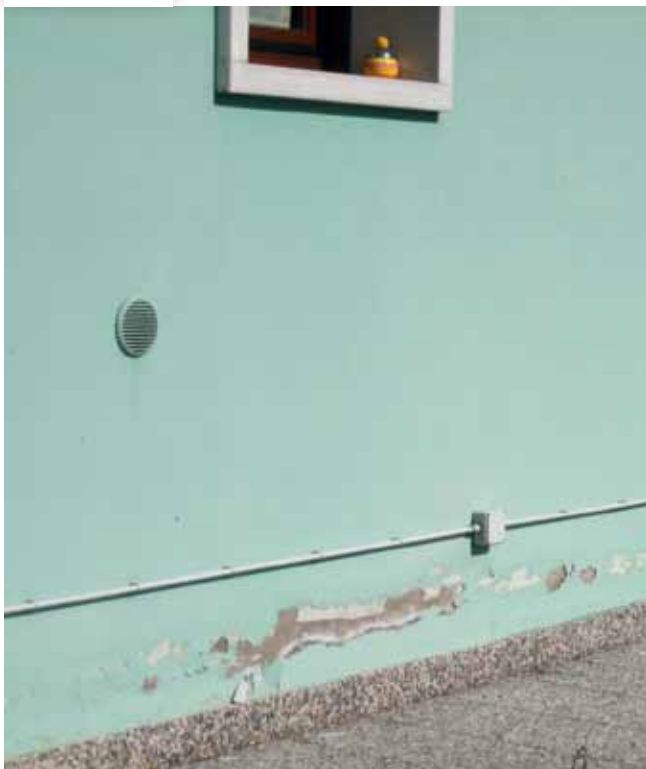
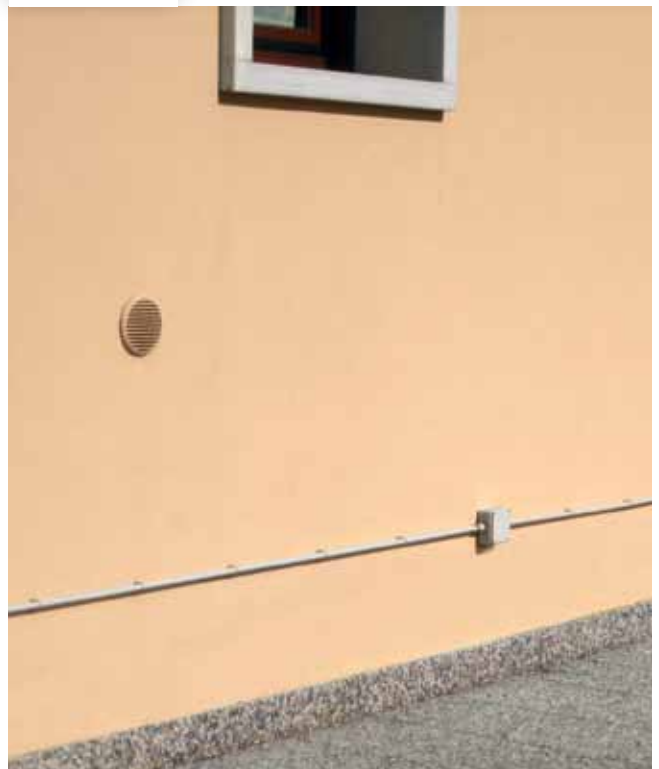
BEFORE

AFTER
